MANAGEMENT OF ROTARY FILE SEPARATION IN MANDIBULAR MOLAR - CASE REPORT

Key words: Intracanal separation, root canal curvature

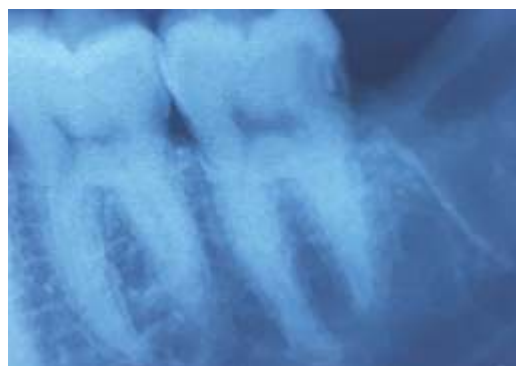
Fig.1

A 34-years old male patient reported to the department of conservative dentistry and endodontics with a chief complaint of pain in the left lower molar tooth since three weeks. Clinically the tooth presented with deep dentinal caries w.r.t 37. Tooth was severely tender to percussion and vitality tests showed painful response to hot, cold and electrical pulp tests. Iopar revealed radiolucency approximating pulp chamber [Fig.1]. From clinical and radiographic findings, a diagnosis of symptomatic apical periodontitis secondary to irreversible pulpitis was made. Treatment options were discussed with the patient and endodontic therapy was the treatment of choice. The tooth was anesthetised with 1.8 ml 2% lignocaine containing 1:200,000 adrenaline followed by rubber dam isolation. Access was prepared to locate all canal orifices and four

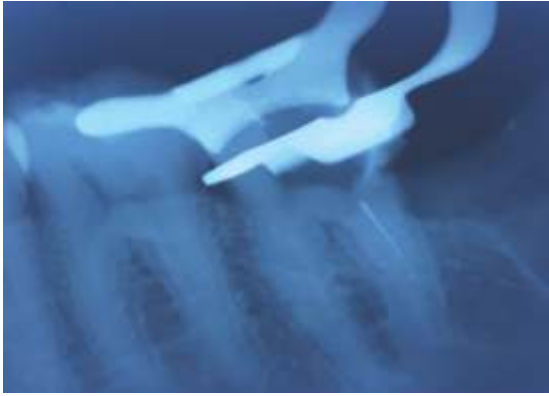
Fig.2

canal orifices were found-mesiobuccal, mesiolingual, distobuccal and distolingual. All the canals were negotiated using a 10-k file. While enlarging the orifice of distolingual canal, the orifice shaper with tip diameter of 0.19 separated leaving a length of 6mm at the orifice level [Fig.2].

Since the fractured segment could be visualised and was above the root curvature, retrieval was preferred over bypassing. Exact location of separated instrument within the canal was confirmed under the Dental operating microscope. Ultrasonic tip ET25 (Acteon, Satelec) [Fig.3] in ultrasonic hand piece at a power setting of 3, was placed into the distolingual canal between the exposed end of the file and the canal wall and activated around the obstruction in a counter clockwise direction to remove dentin around the fractured instrument and loosen it. Following the ultrasonic activation, the instrument fragment floated out from the distolingual canal [Fig.4]. Working length was established with the help of an apex locator (J Morita Inc, USA). During the shaping of canals, copious irrigation with 3% sodium hypochlorite and saline was performed. Patency was kept with a 10 size K file between every instrument. Shaping of all four canals were done upto #0.06/25. Canals were irrigated with 3% sodium hypochlorite, 17% EDTA and 2% chlorhexidine. Canals were dried using paper points and a master cone radiograph [Fig.5] was taken to check the apical fit in all the four canals. Finally canals were obturated with gutta-percha and AH plus sealer (Dentsply) by warm vertical compaction [Fig.6]. The access preparation was sealed and the post endodontic composite restoration was done.
